In-situ process recent data: Tile 21

In-situ process recent data: Tile 23

In-situ process recent data: Tile 24

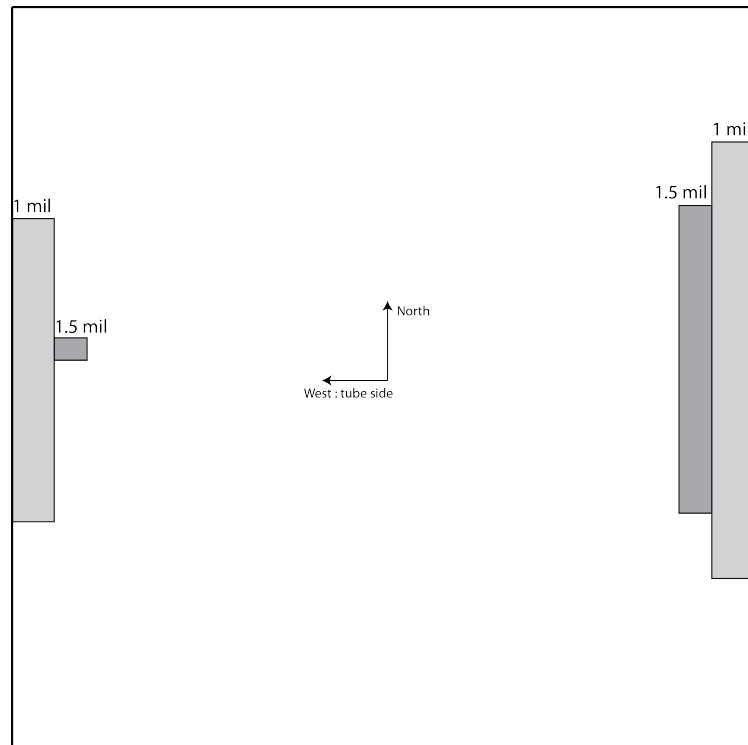
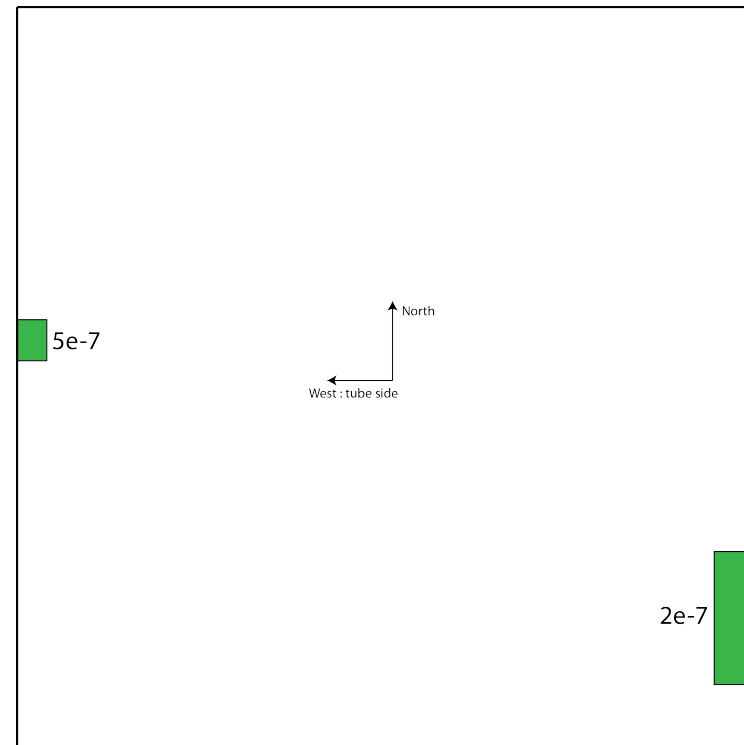
- ICE ceramic tile, 99.8% pure alumina
- Clausing seal-metal coating
- Window with big tabs and extraneous metalization
- 20% of indium lost outside the tile

- Shim test leaves major scratches on window
- Window and sidewall do not always sit flush (even with no stack)
- Gaps in shim test disappear with as little as 0.7 lbs pressure per spring
- Vac-seal got total leak rate down to 2e-9

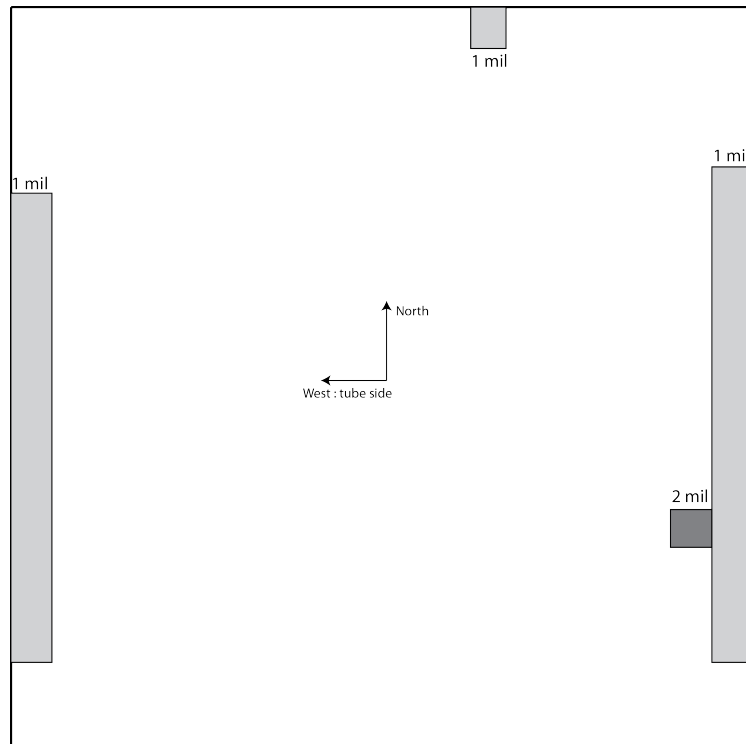
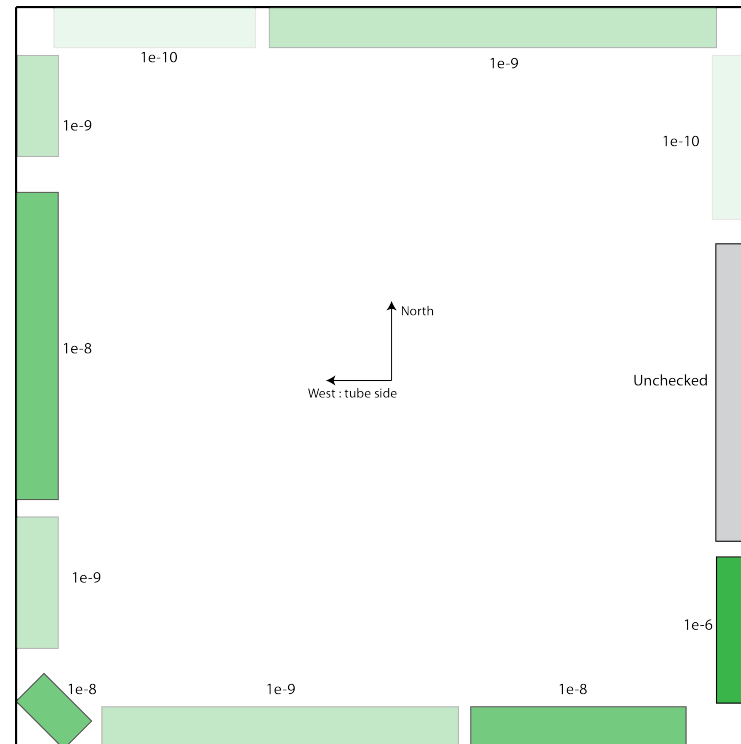
- ICE ceramic tile, 99.8% pure alumina
- Clausing seal-metal coating
- Window metalization matches the sidewall, small tabs
- 25% of indium lost outside of tile, more lost inside

- Tubes leak at $1e-4$, pins leak at $1e-5$
- External HV electrodes work and do not arc, but discharging on empty sidewall at 2600V
- First tile with 10g of getter material, did not spark
- **Leaky patch in seal has BARE ALUMINA showing after we pry off the window**
- Many SEM pictures and thoughts after prying off window

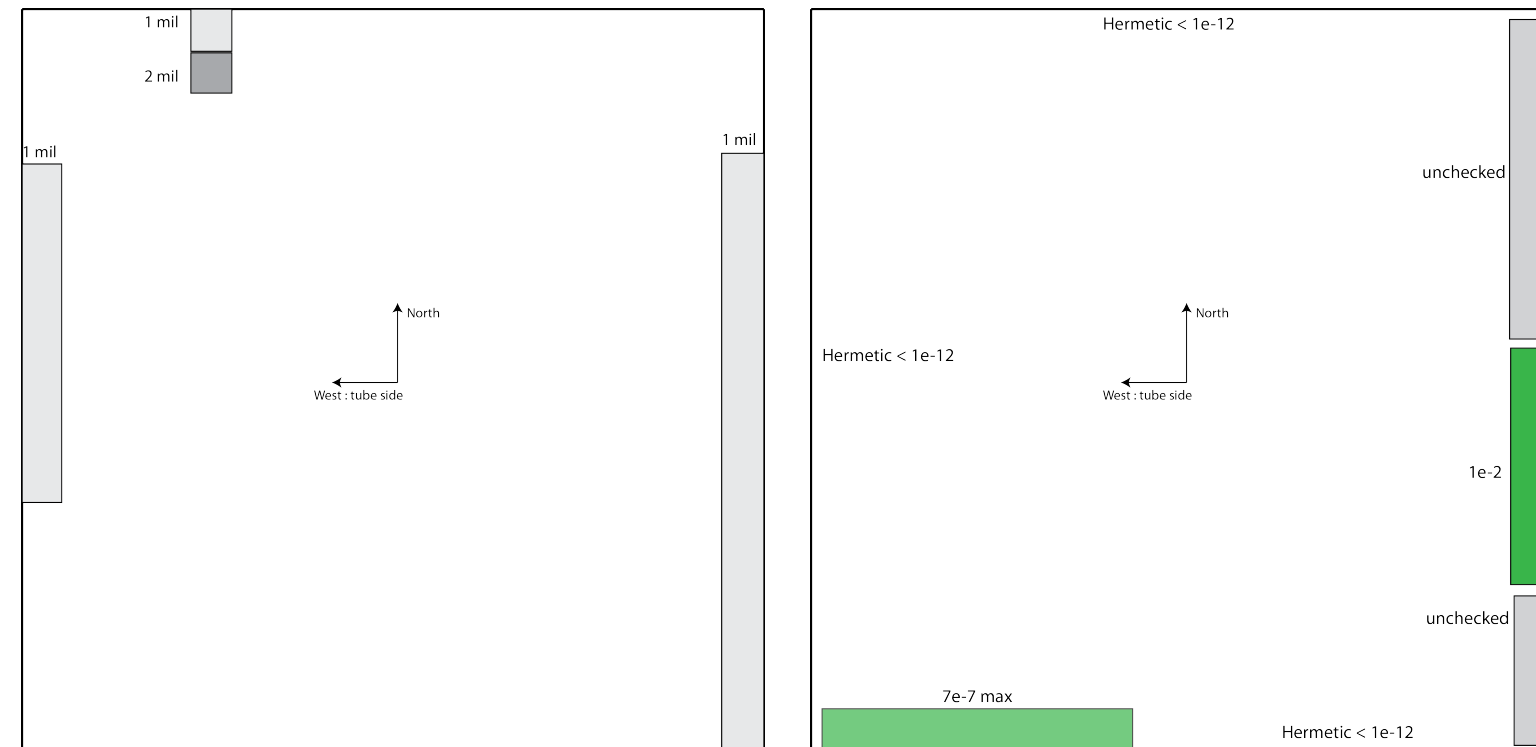
- **Friatec** ceramic, 99.8% pure alumina
- **Abrisa** seal-metal coating
- Window metalization matches the sidewall, small tabs
- Antimony film on window has no Nickel tie-layer
- 0% indium lost

- 1mil – 3mil gaps in the seal perimeter where leaks are found: **something held the window up (or other interpretation)**

- The most hermetically sealed tile to date: never have we seen $< 1e-12$ leak on a sidewall, let alone two full sides
- All tubes and pins are completely hermetic to $< 1e-12$
