Problems solved and problems not-solved since the last GP review

Evan Angelico

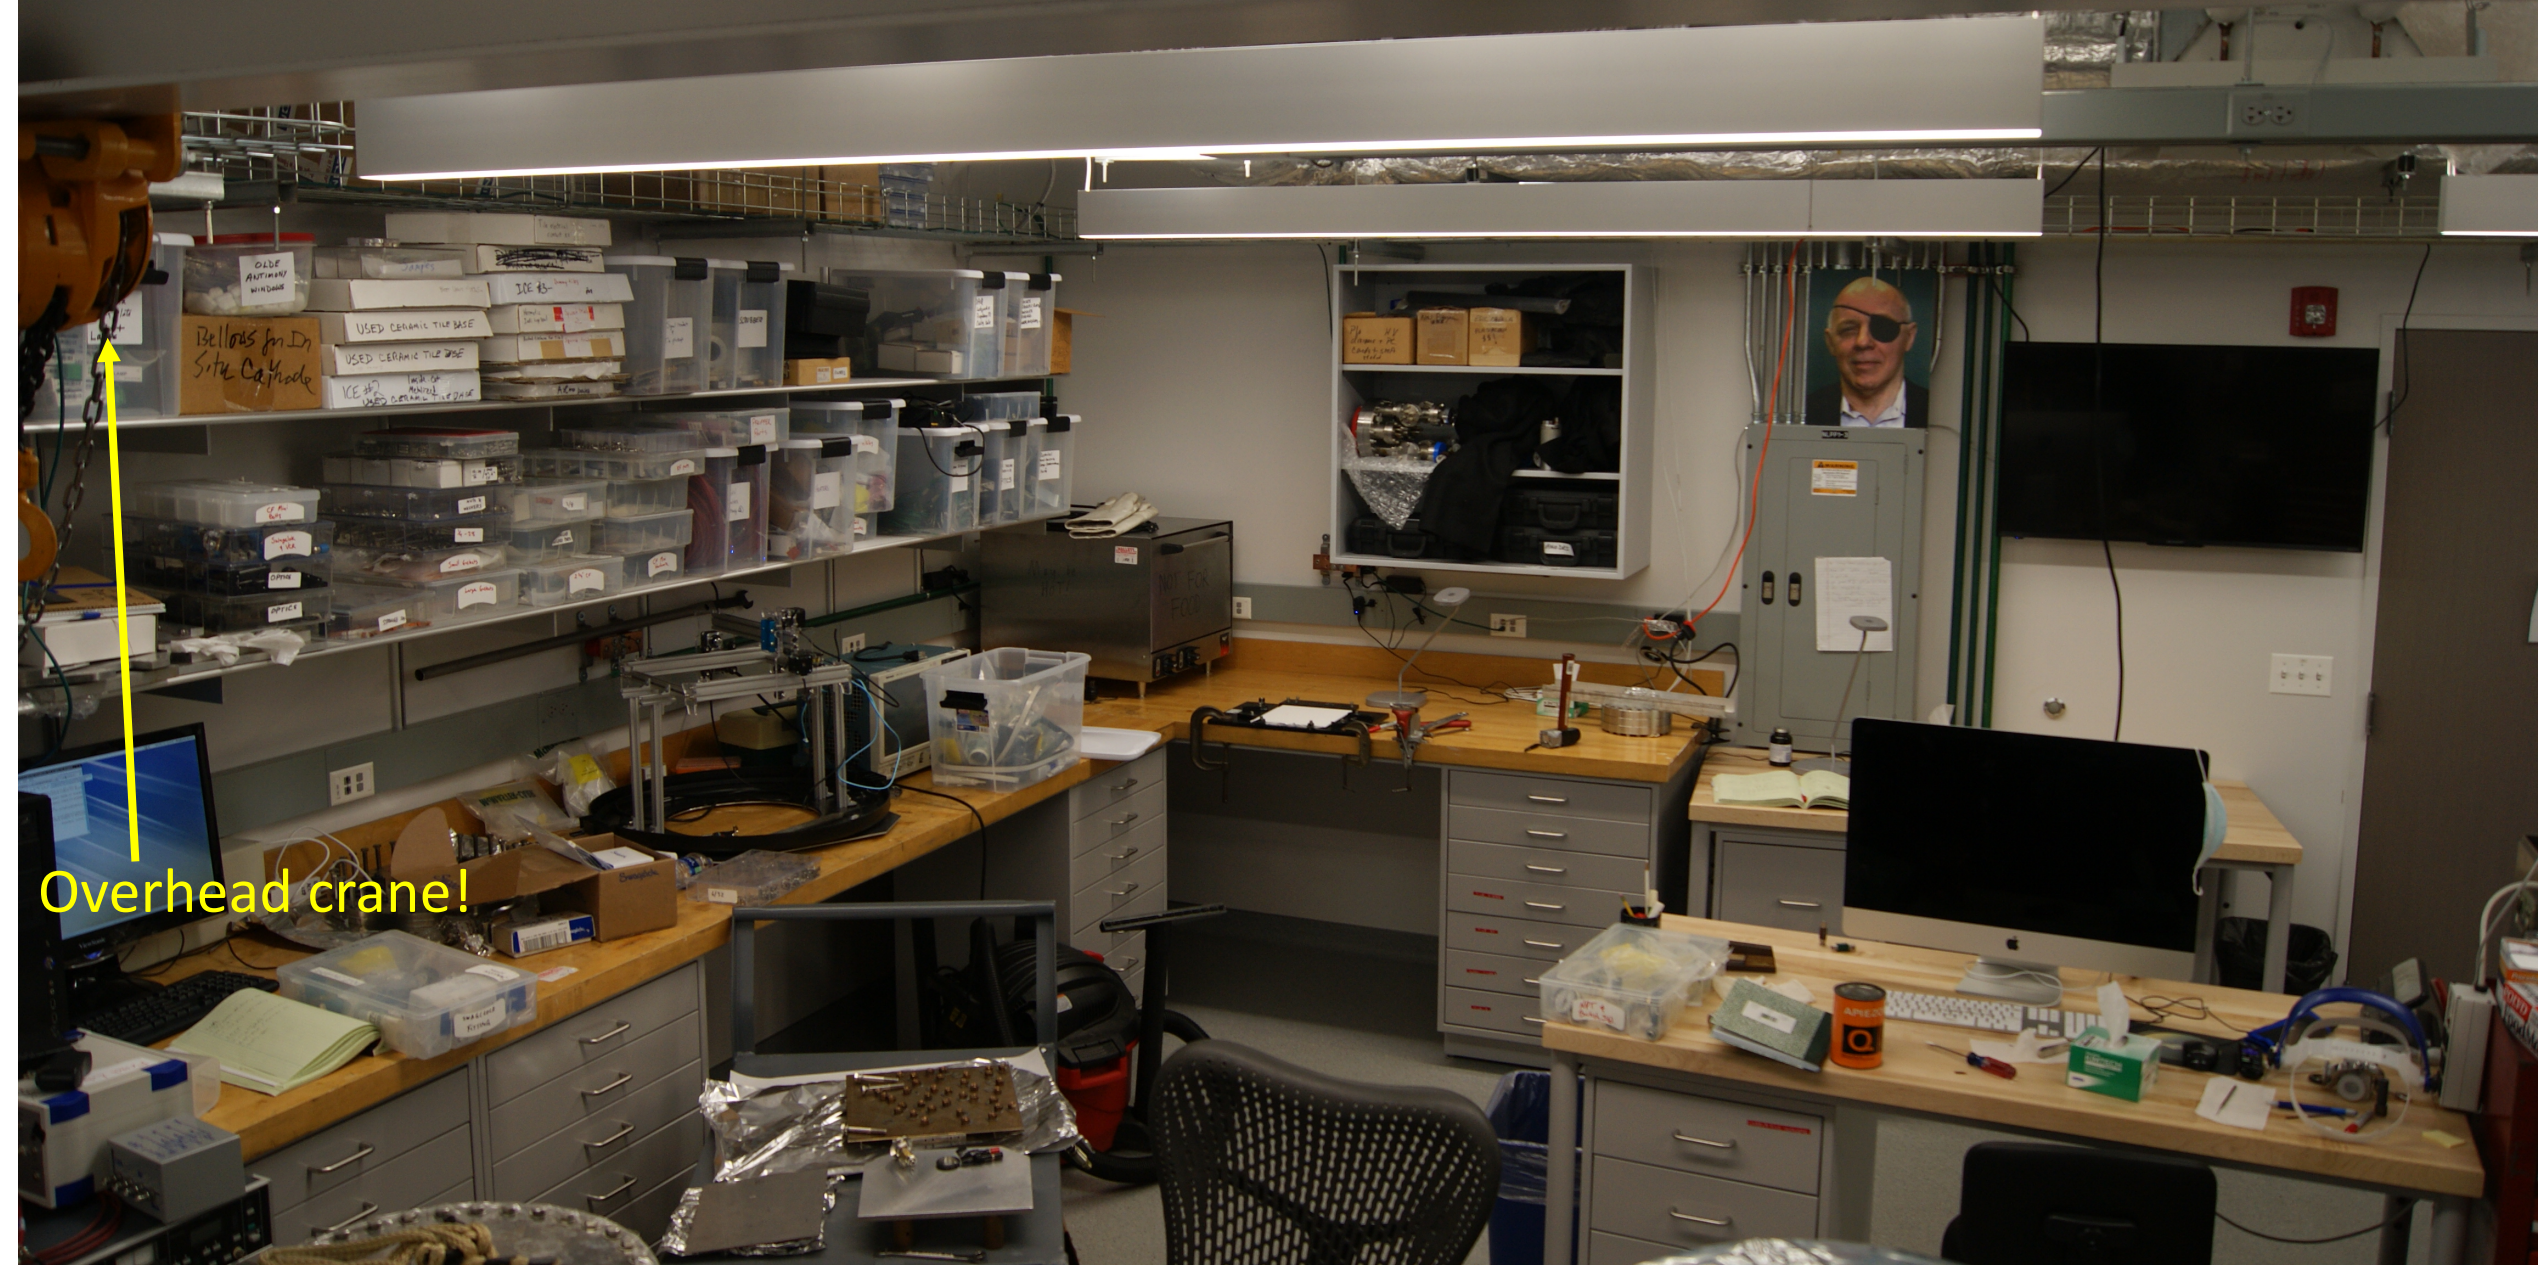
Overhead crane!

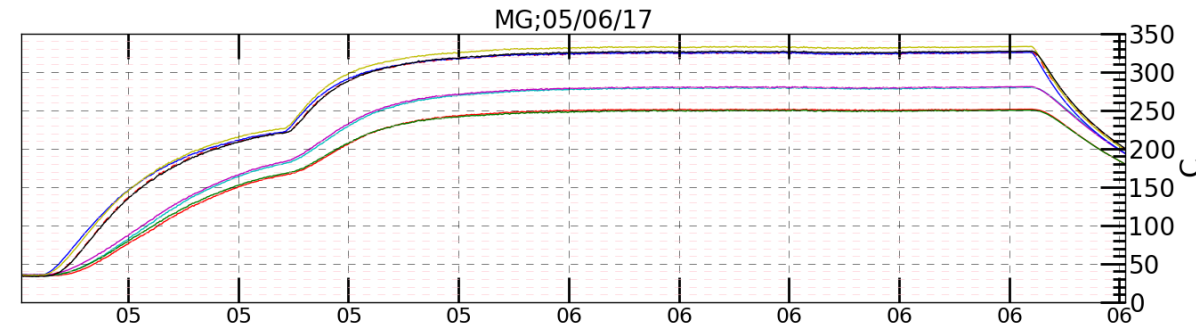
- In house Indium etching
- In house MCP baking
- <1 mil precision on stack height
- Quartz-tungsten lamps → NiCr heaters

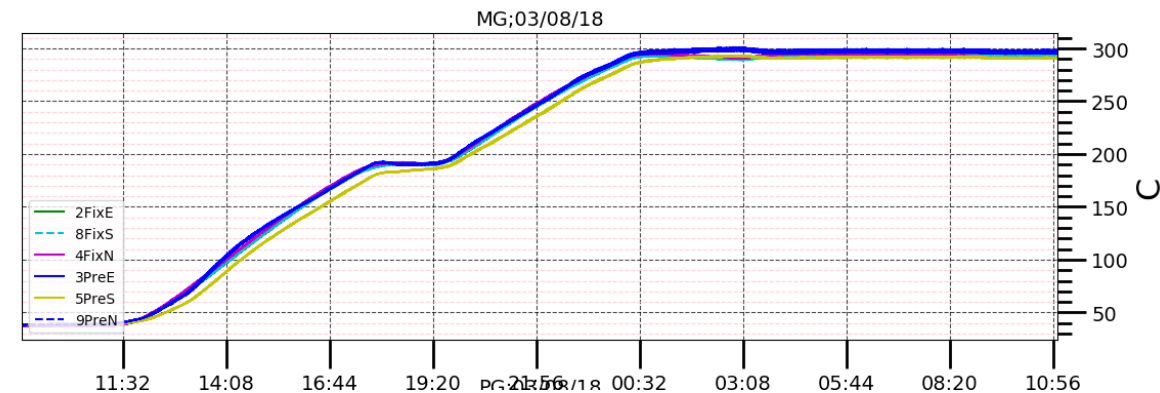
- Thermal uniformity of the LAPPD in production
 - Insulation and heater design a-la Eric
 - ~5 degree C spread between window and ba
 - Indium is uniform to 5C

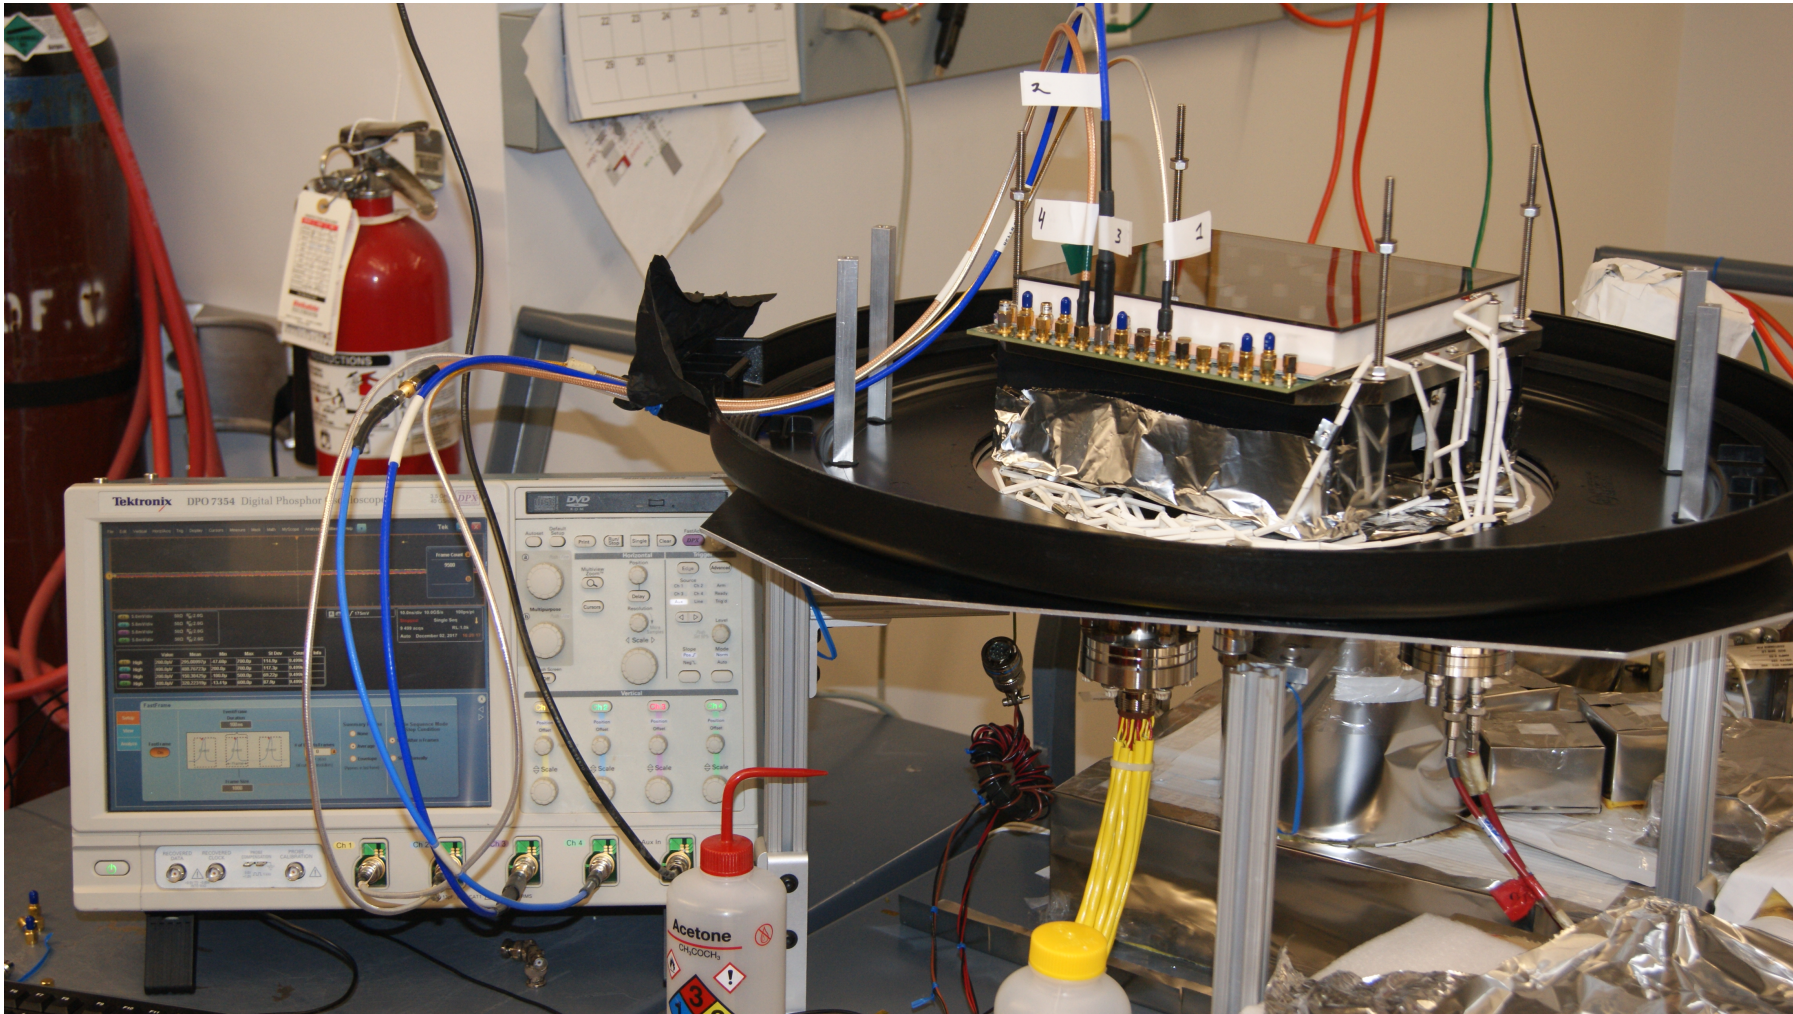
- In-situ pulse readout with 30 channels

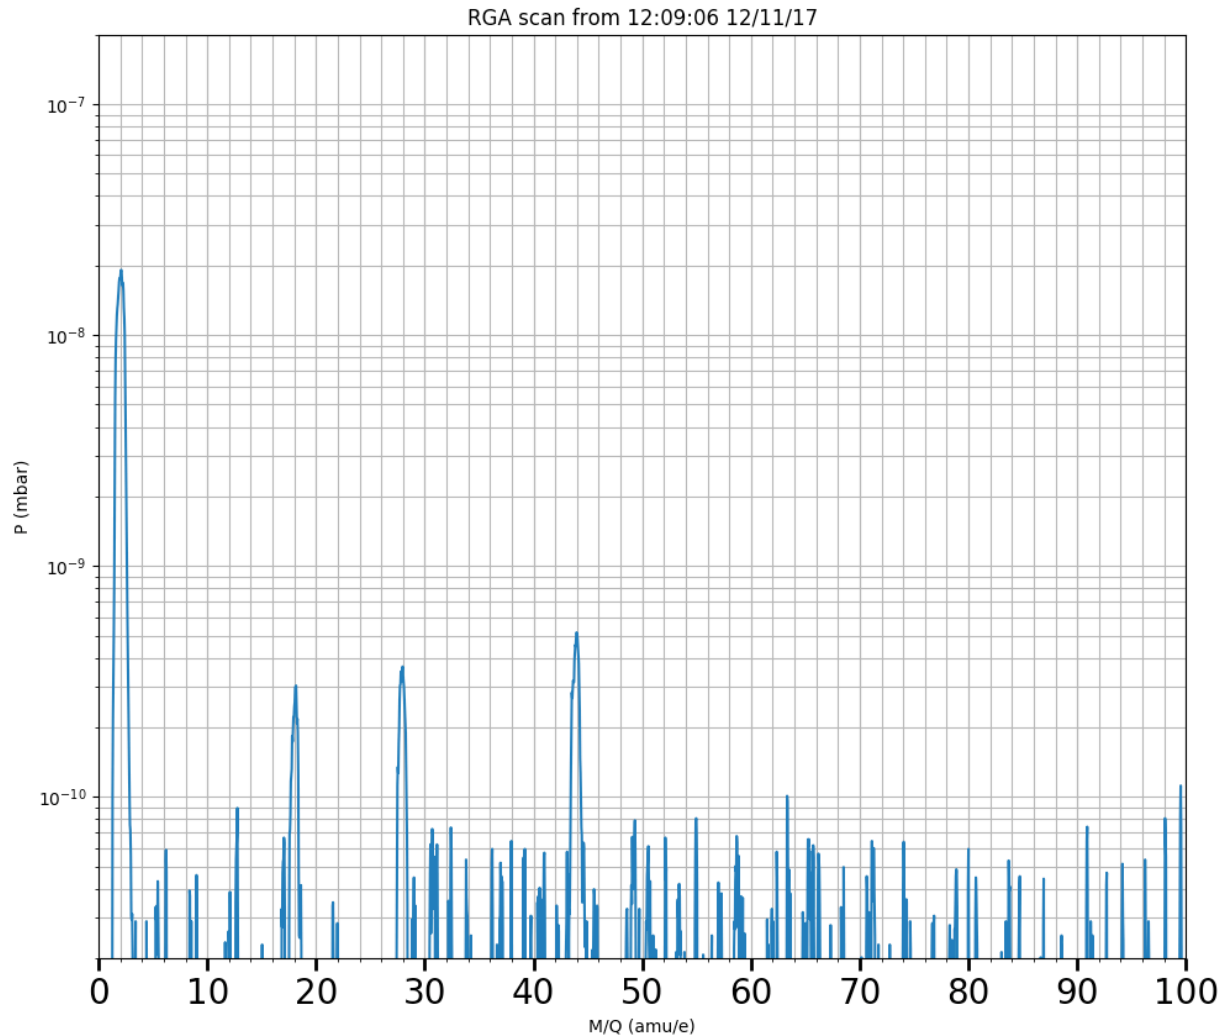
- Improved cleanliness of Cs manifold and temperature control

- Manifold pressure is below detection threshold ($2e-9$) at cesiation temperatures
- RGA filament dominates pressure (we now know how to degas it effectively)
- More in session 5

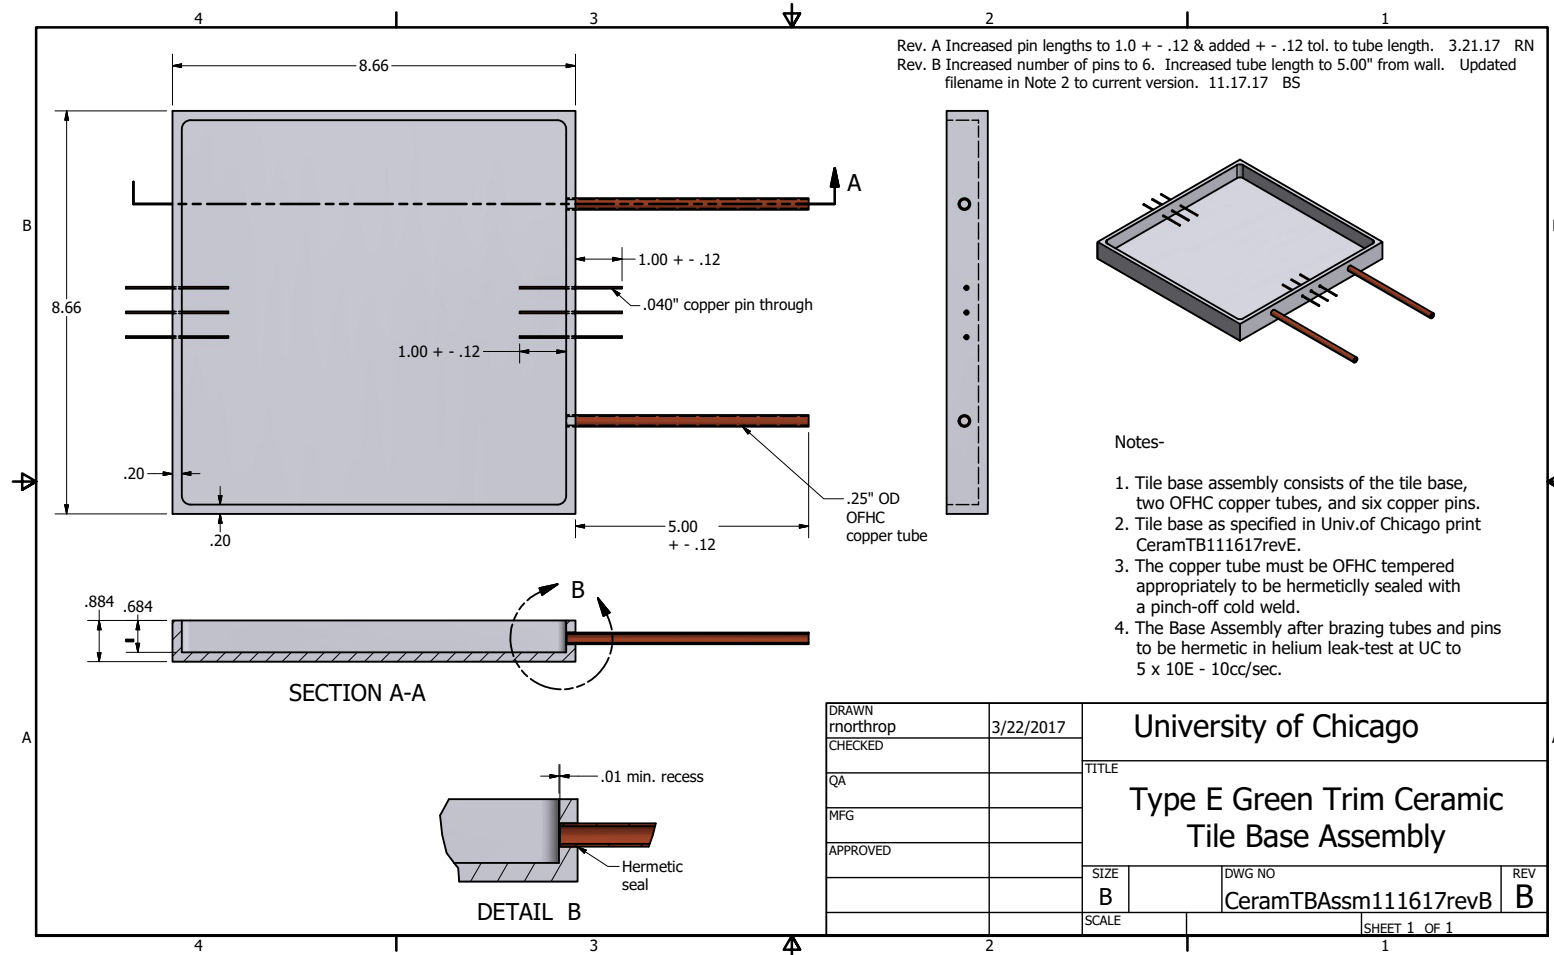
External voltage divider:

- Accurate QE measurement
- Optimize gap voltages for best timing
- Measure isolated MCP resistance during cesiation

External voltage divider

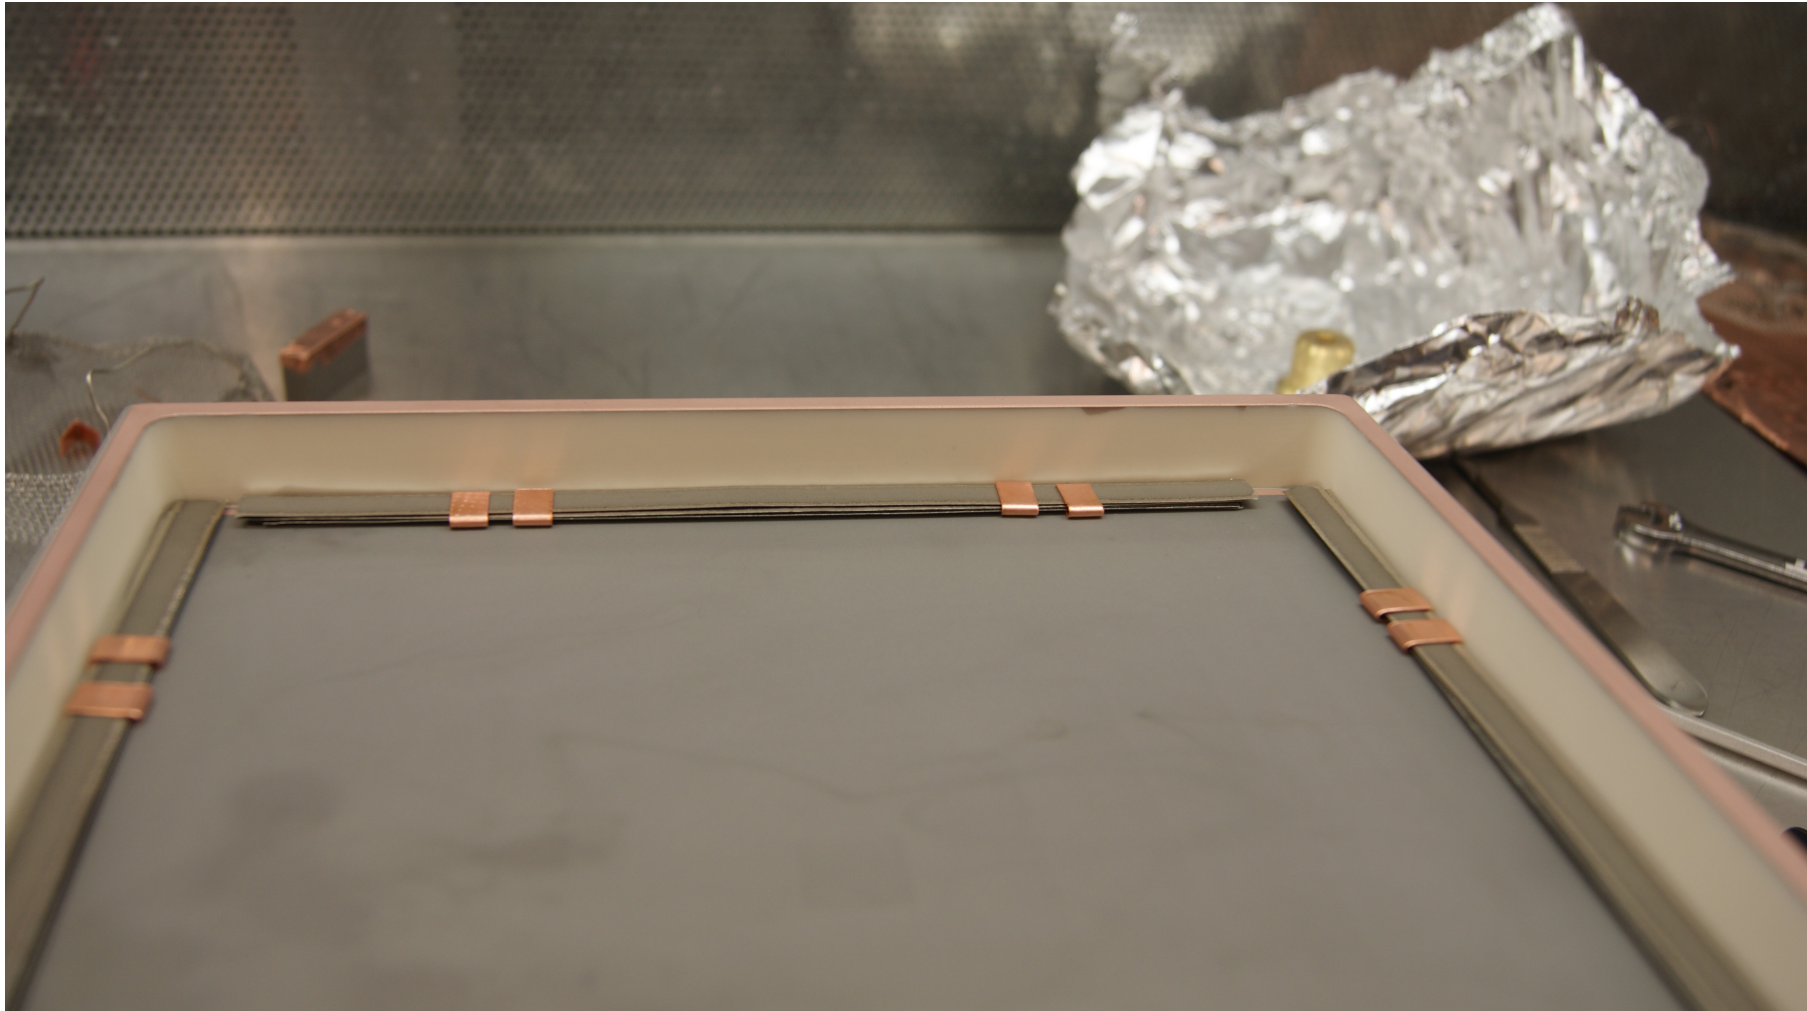
- Getter mounting, 10g of active material

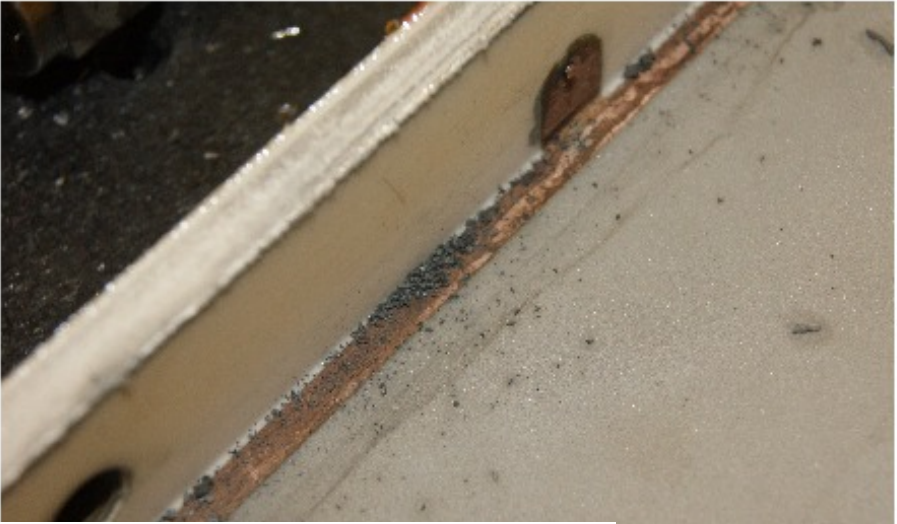
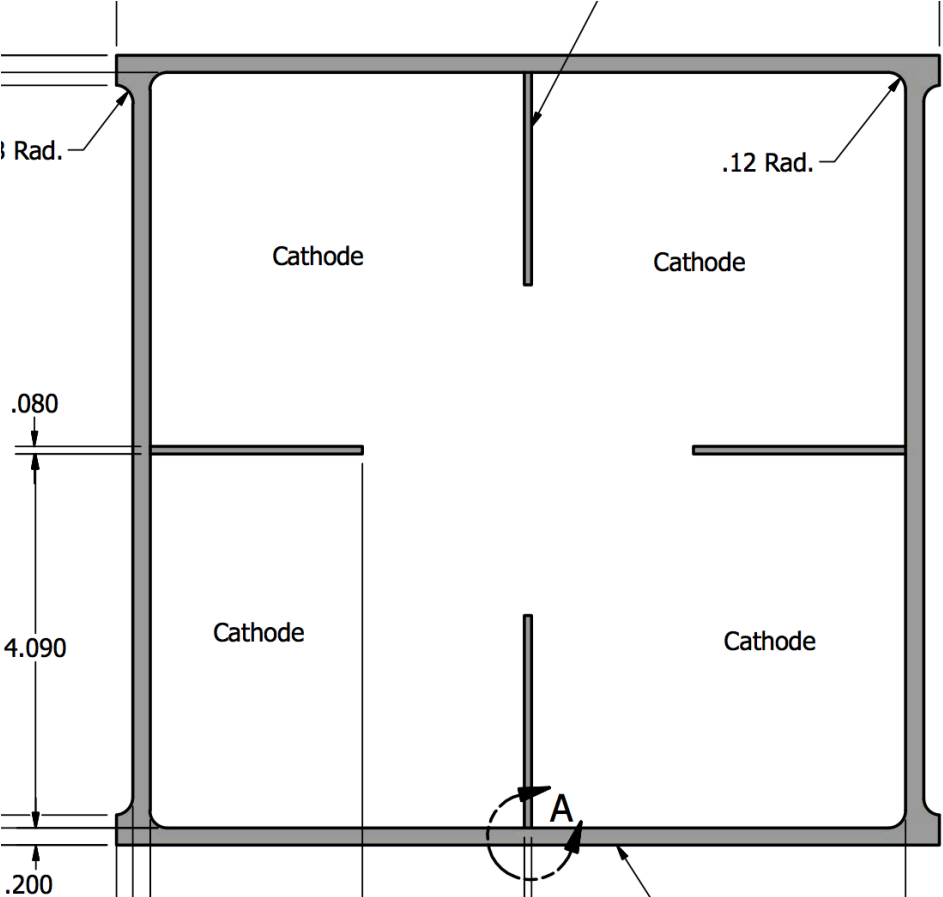
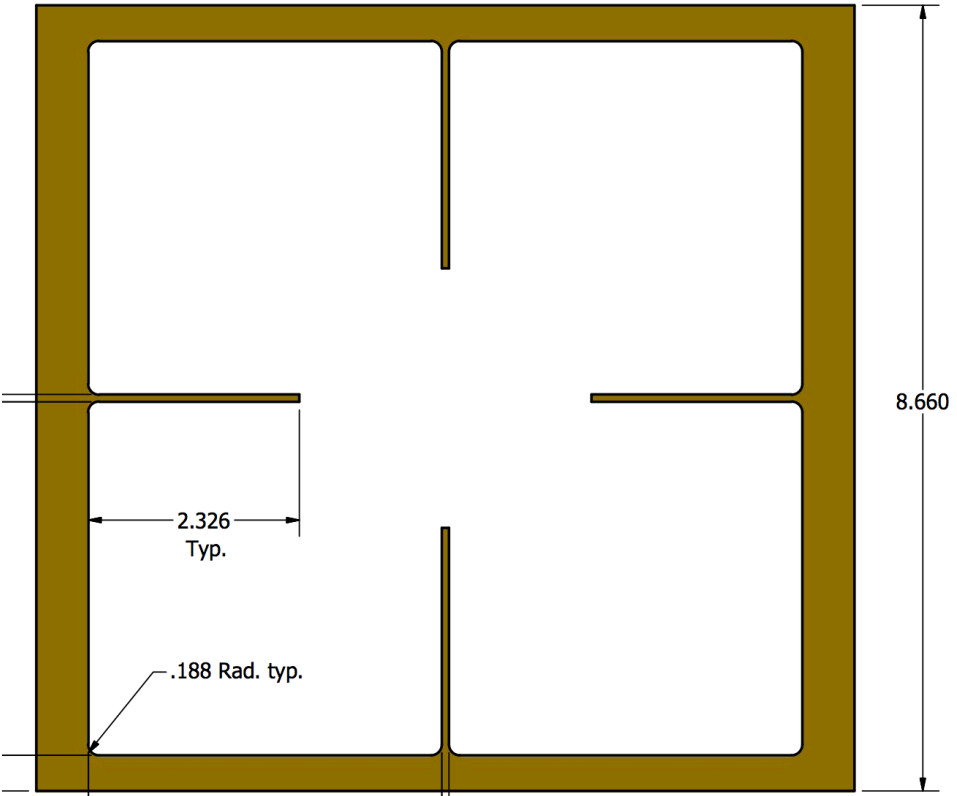
- Window metalization change
 - Indium wicking, loss of indium mass
 - Indium-Cesium mixture makes powder

the tile, in crevices and on the window. It was colored on the window, and flaked

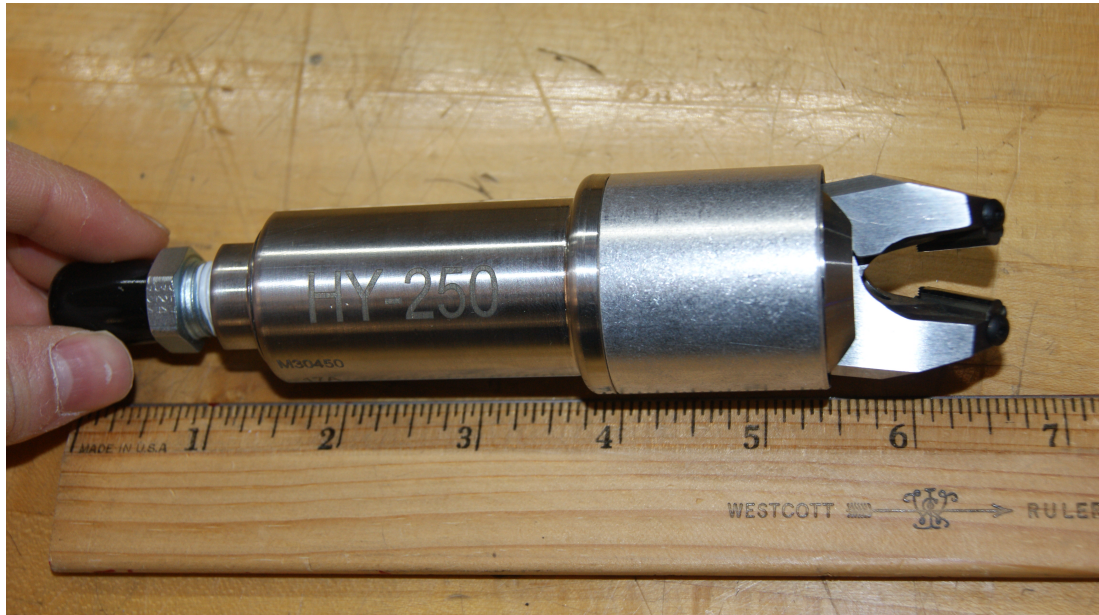
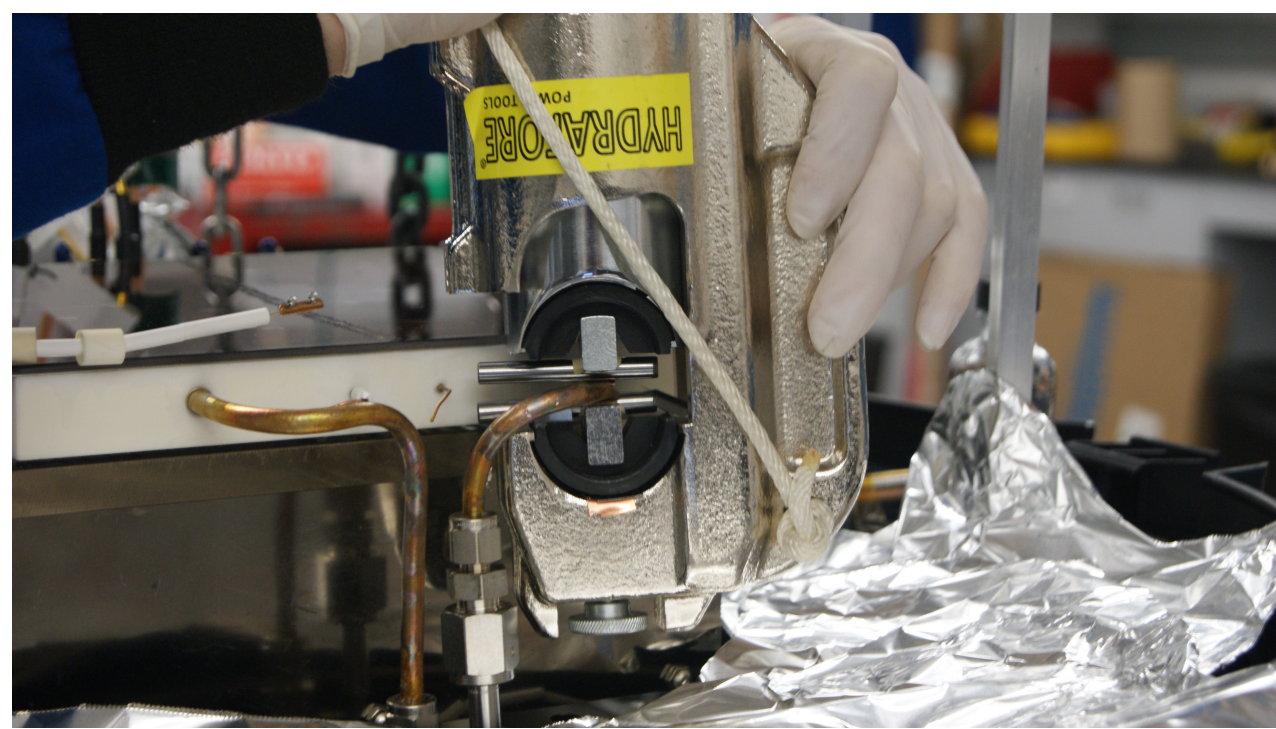
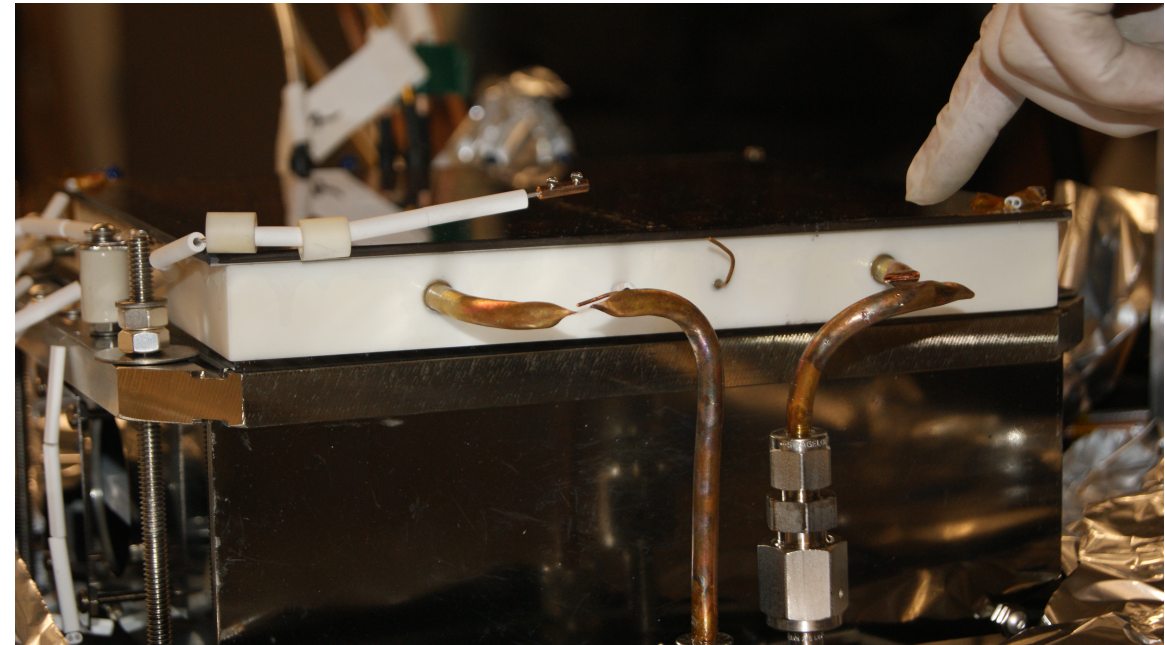
- Copper tube pinch-off

New tool to try out next time

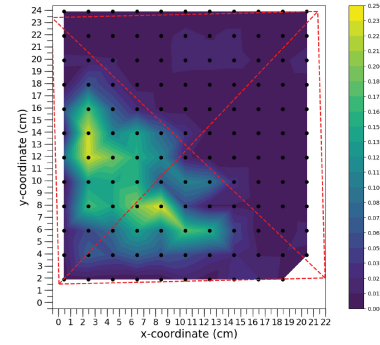
After 24 hours of cesiation

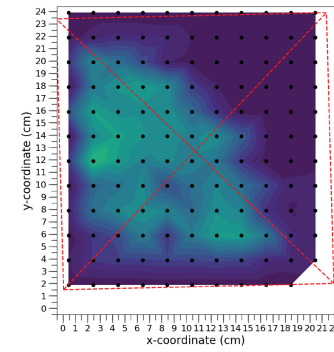
After 48 hours of cesiation

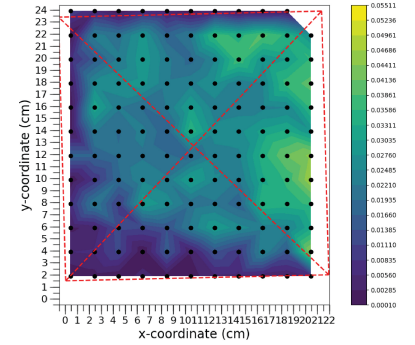
Increase j-tube from 145C-190C, cesiate for 2 hours then close source, and sit for 50 hours

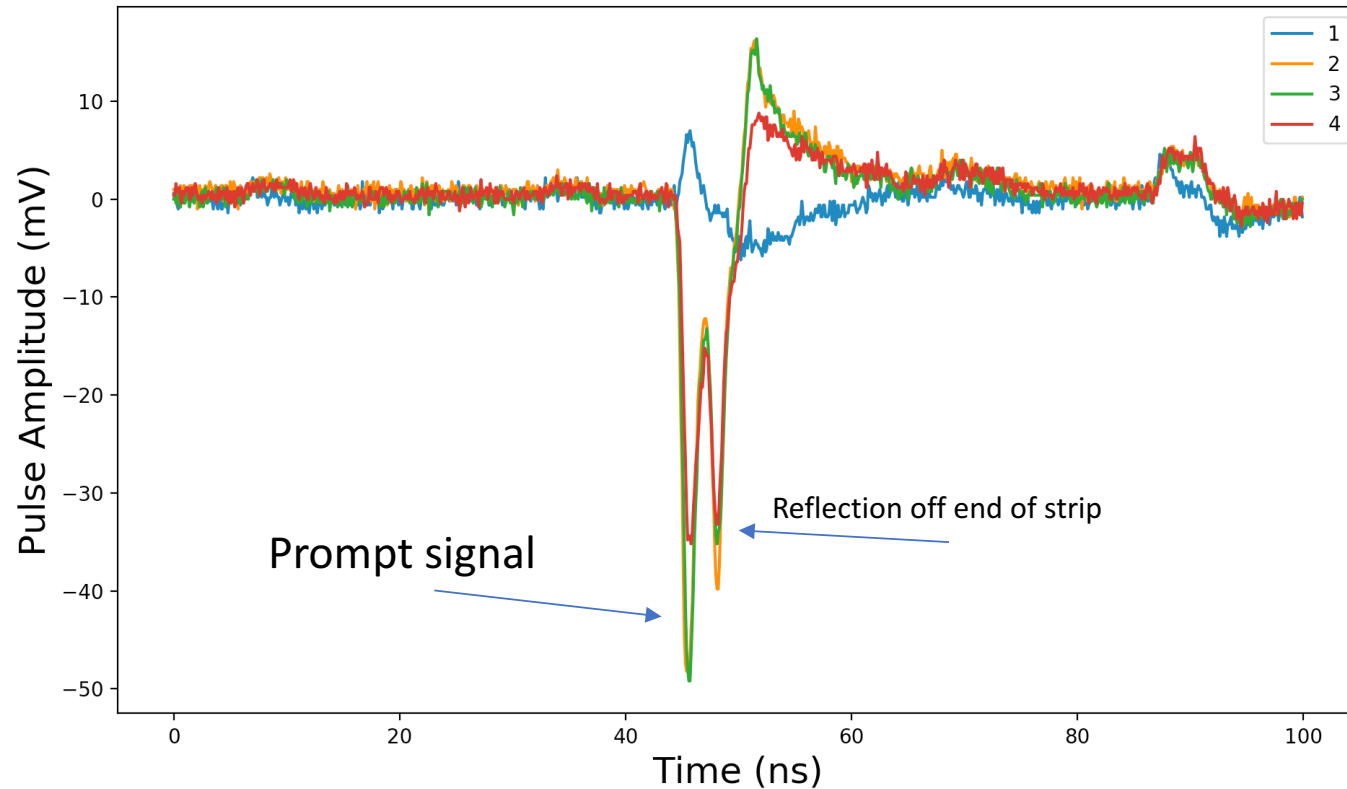
Event number: 418

Tile 21 pulses!

Capacitive pickup, 30 strip-line readout

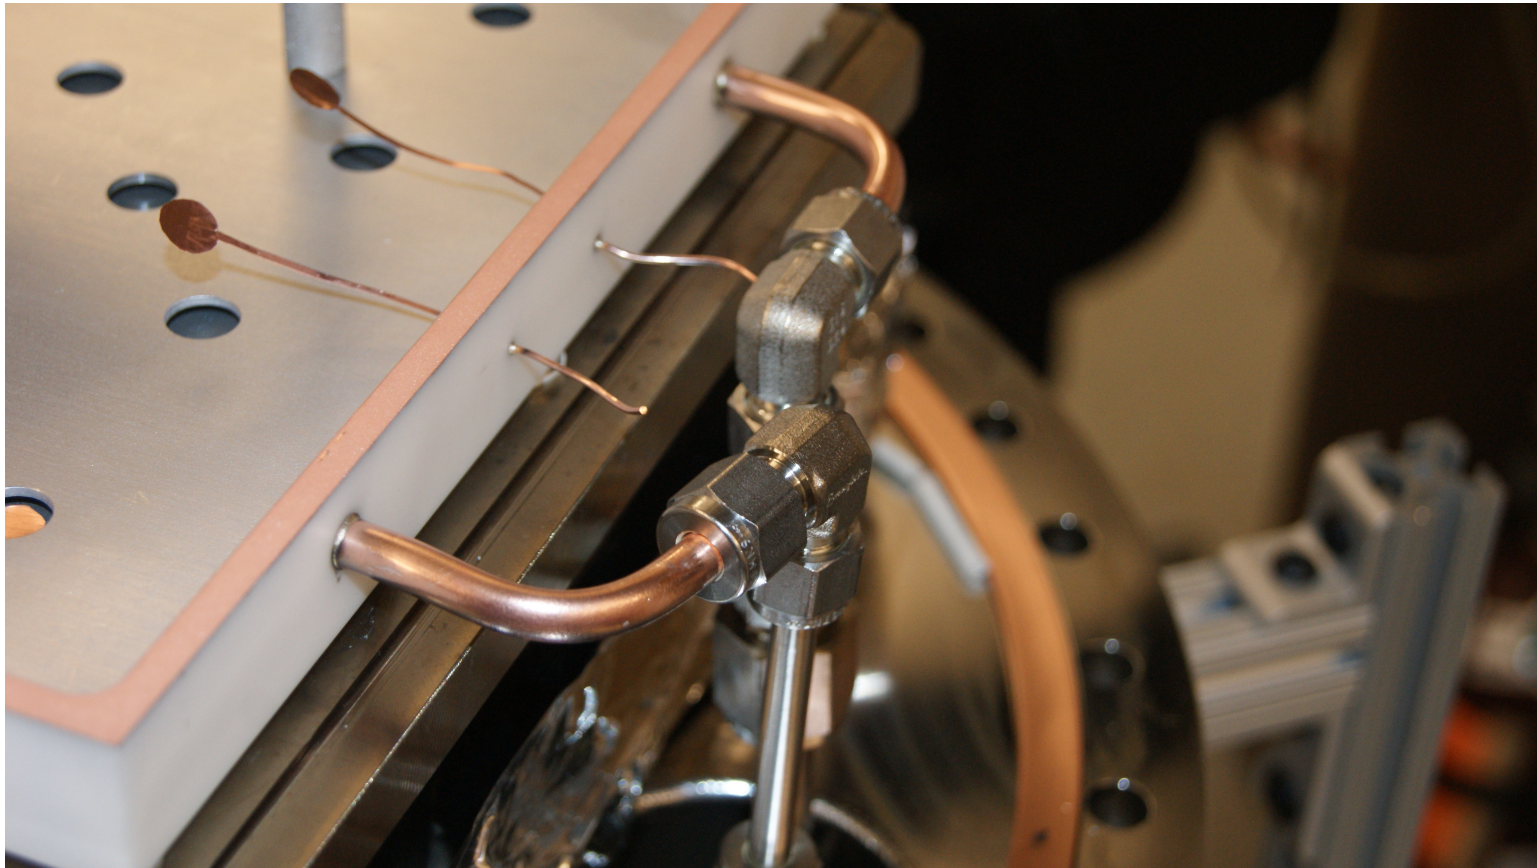
~~Leaking brazed tubes and pin feedthroughs~~ →

Tile 24, brazed by Friatec has completely hermetic pins and tubes after heat cycle!

Only one trial though...

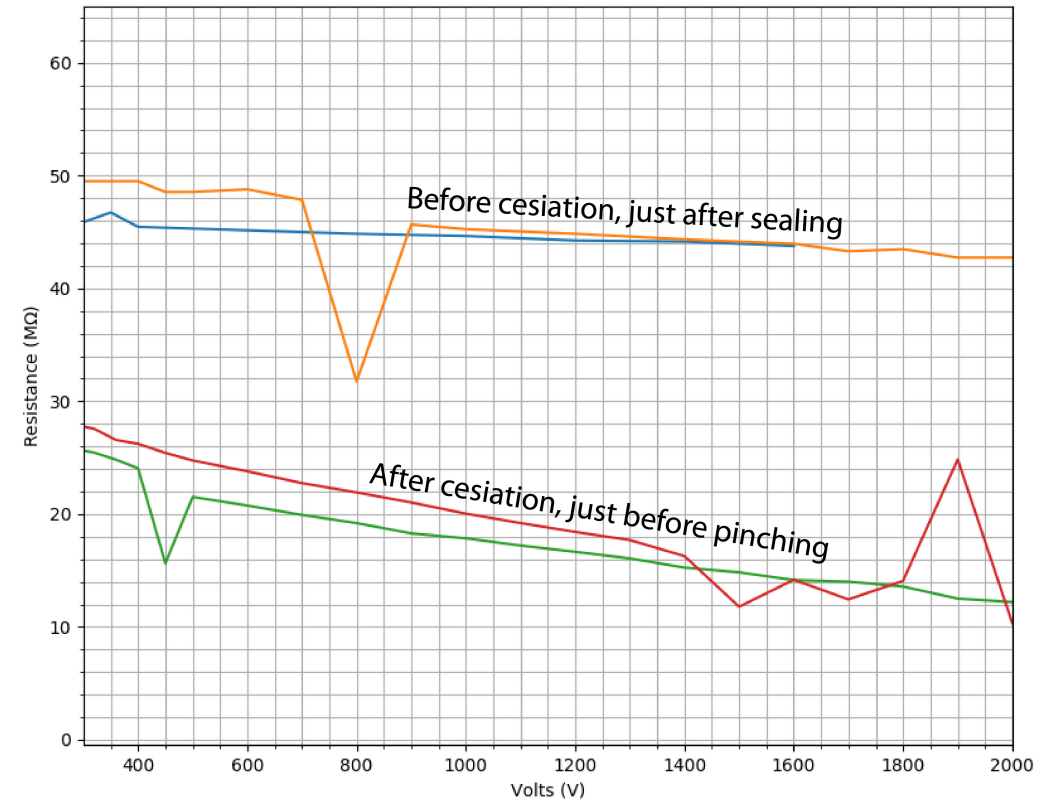
1. Open Cs valve, source at 145C
2. At 50 h, increase the source temperature to 185C
3. Close 2 hours after reaching hotter temperature

- Photosensitivity everywhere (not uniform, >30%?)
- Reduction in total stack resistance
- BUT, MCPs survive enough to produce high gain pulses on 30 strip-line capacitive readout

Need a QE measurement, no QE measurement thus far

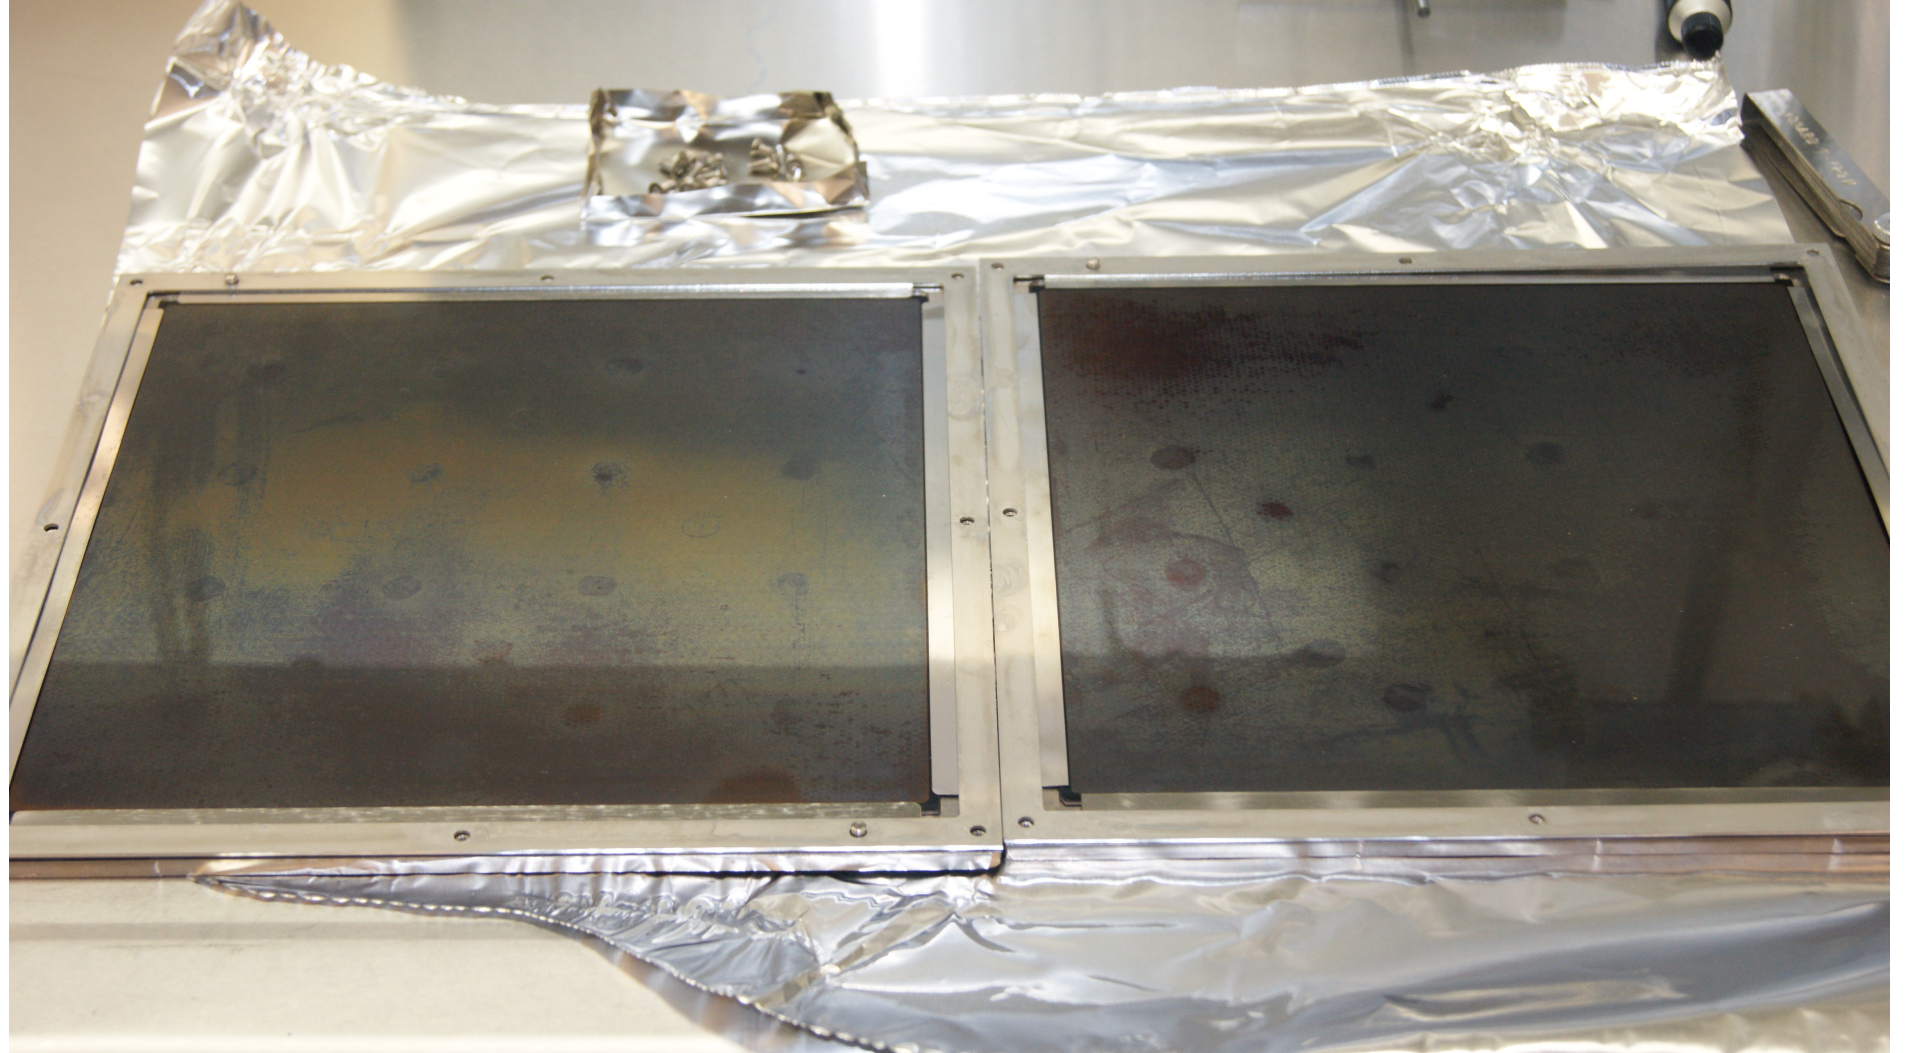
MCP production bottle-neck

- Reusing MCPs
- Arradiance
