# Instrumentation, Monitoring and Control for the Insitu Process

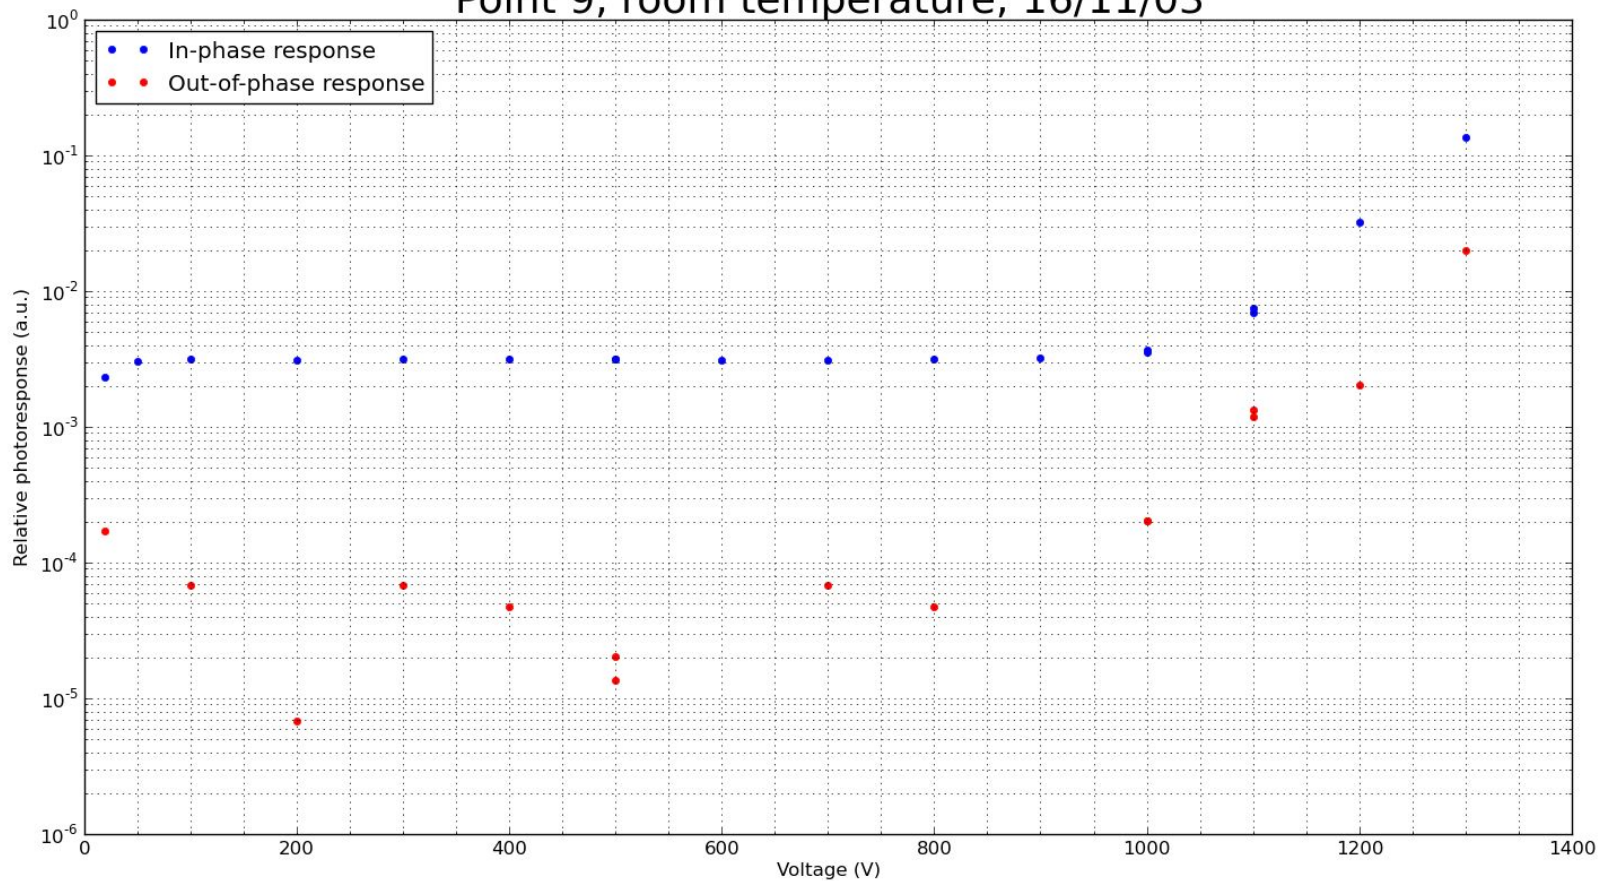
Relative photoresponse vs bias voltage from:

# Point 9, room temperature, 16/11/03

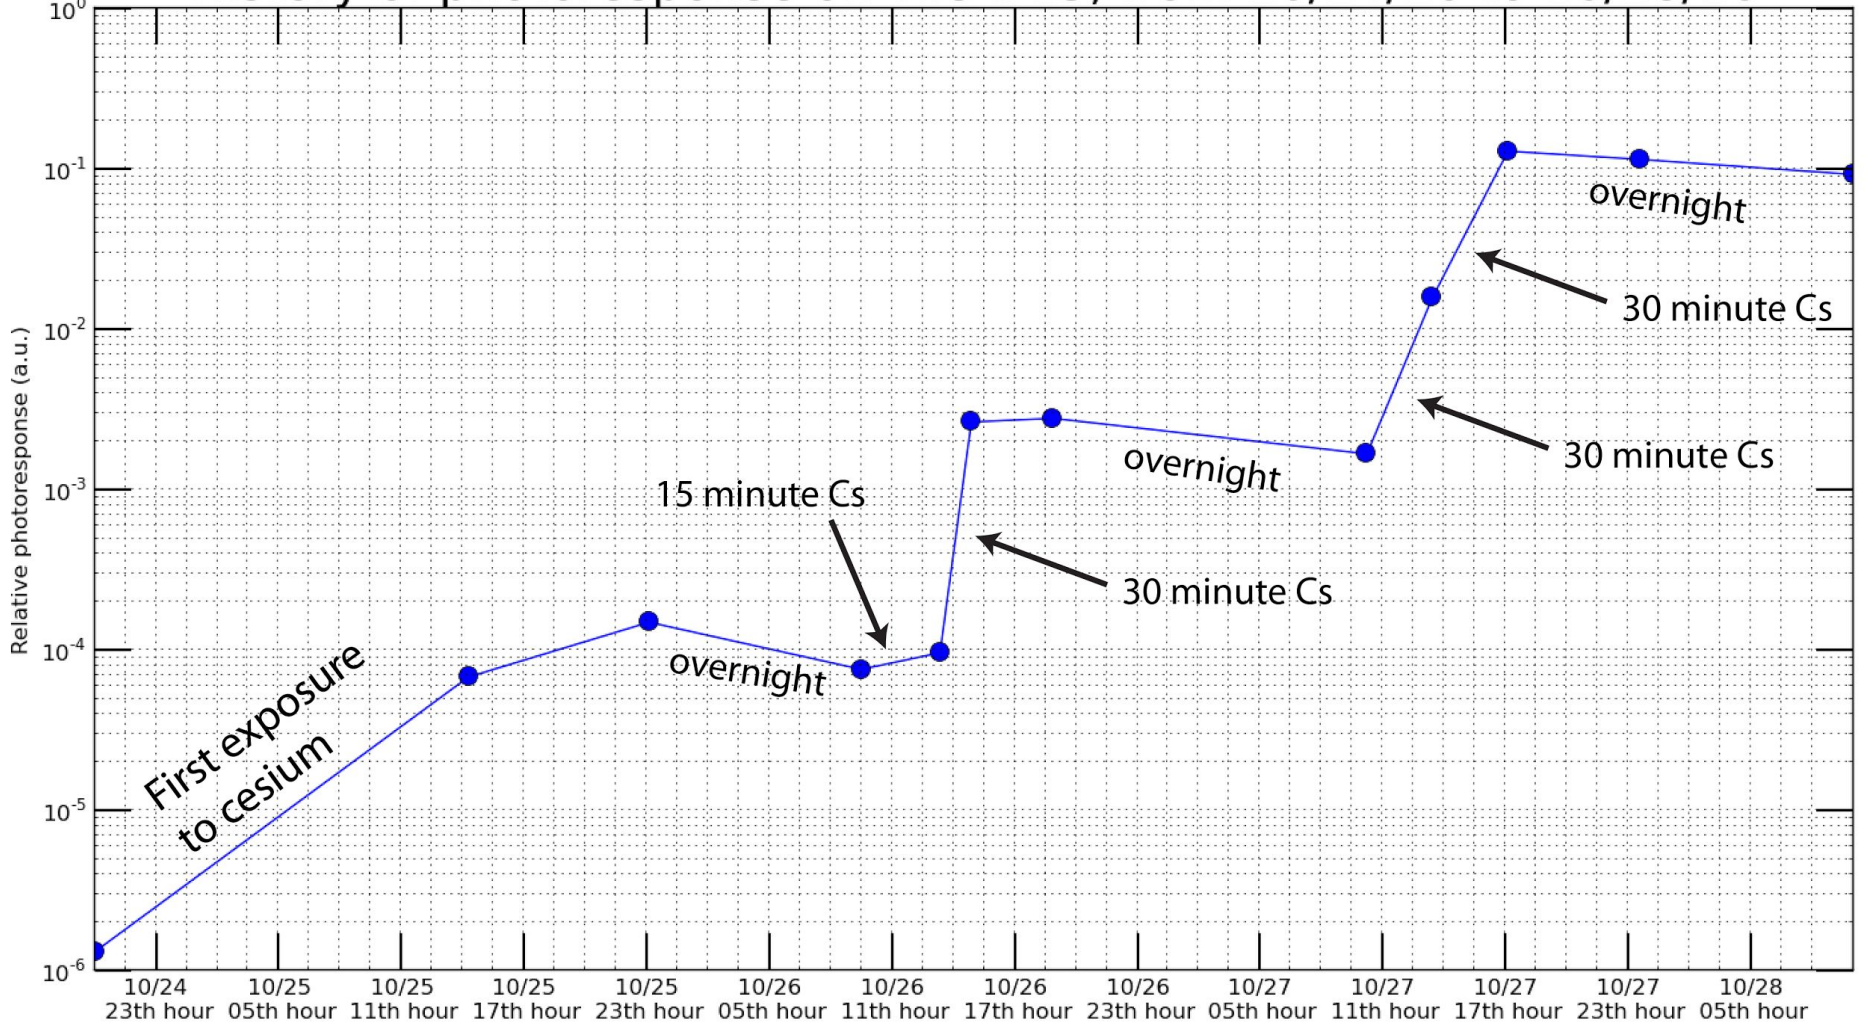
# History of photoresponse on Tile #13, from 10/24/16 to 10/28/16

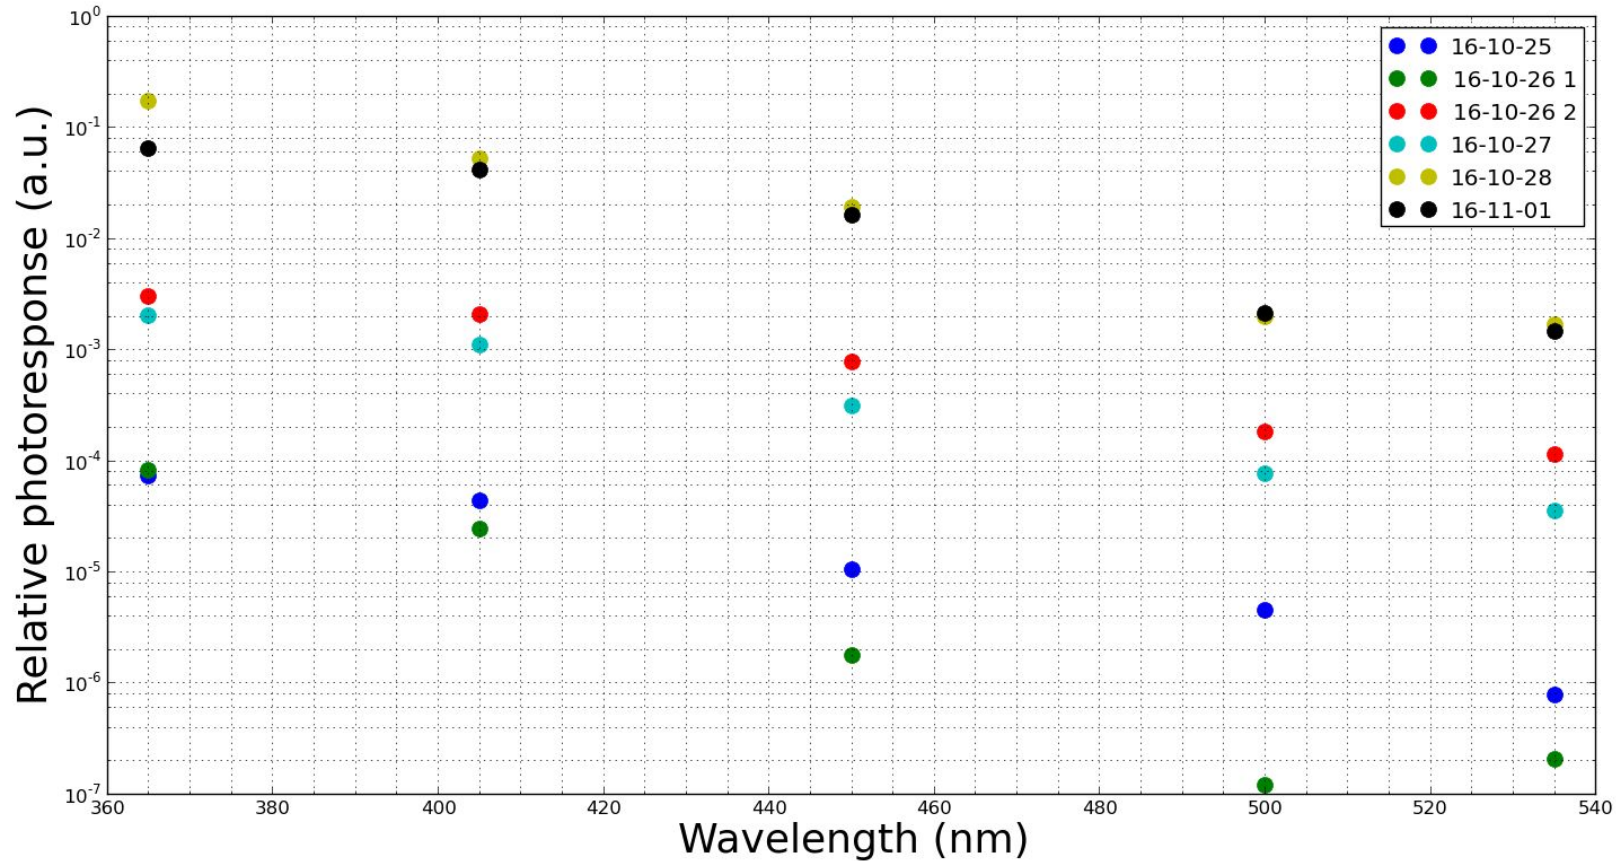
Relative photoresponse vs wavelength over time
